# LAKE CLASSIFICATION SHORT REPORT ON PEPPERMILL LAKE, ADAMS COUNTY, WI

Presented by Reesa Evans, Lake Specialist Adams County Land & Water Conservation Department P.O. Box 287, Friendship, WI 53934

OCTOBER 2007

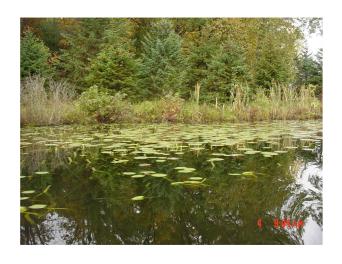
Some wetland area on Peppermill Lake

The photo to the right shows one of the wetlands along Peppermill Lake's shore. It is essential to preserve the wetlands for the continued health of Peppermill Lake waters.
